Improving Energy Efficiency of Older Buildings

David L Wolff AIA

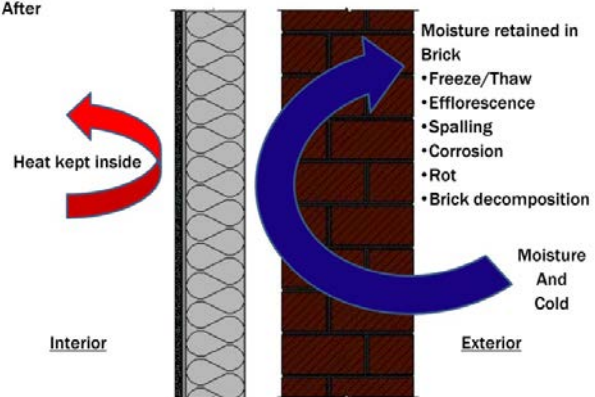
After

When we add interior insulation (and often also a vapor barrier) to a wall assembly, the hygrothermic performance changes. The wall stays colder, and thus wetter, as it loses its ability to dry to the inside. That extra moisture can cause serious problems such as mold, decomposition of the brick and mortar, corrosion of metal fasteners in the wall, rot of wooden beams bearing in masonry beam pockets, efflorescence, and in colder climates, spalling due to freeze/thaw cycling.
